DOT/FAA/AR-96/21

Composite Failure Analysis Handbook Update 1

August 1997

Final Report

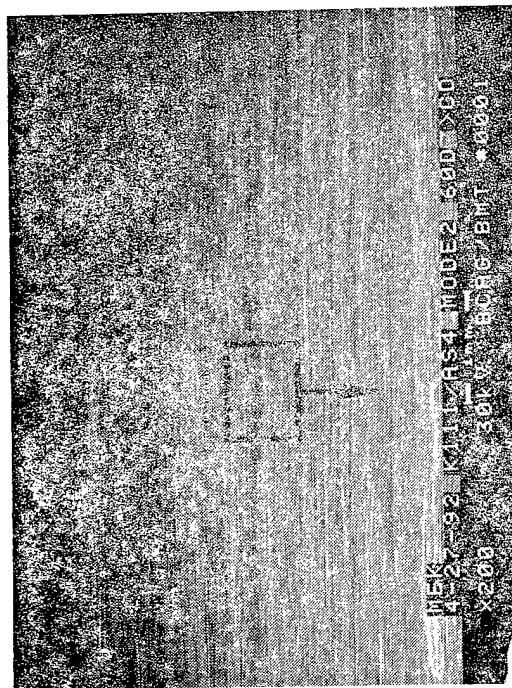
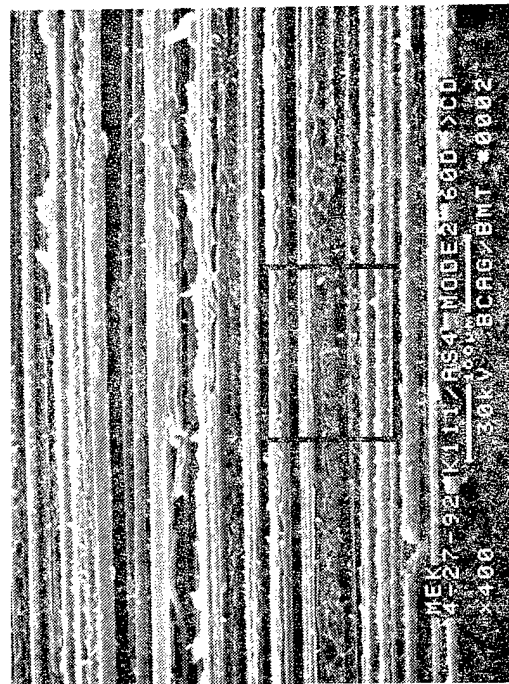
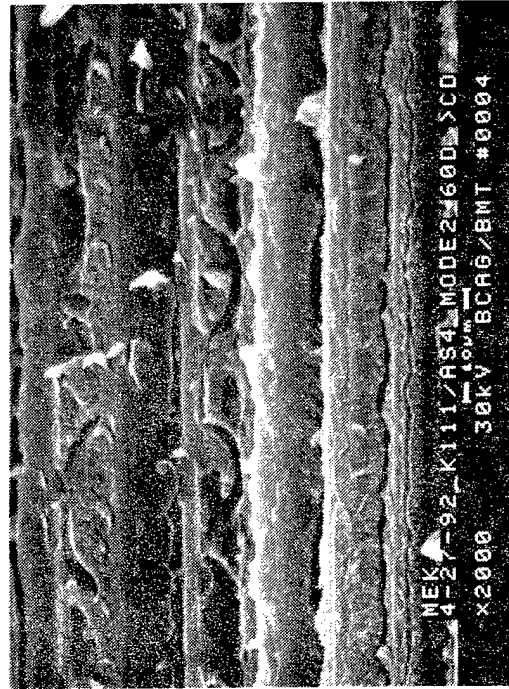
Figure 3.2-22. SEM Fractographs of a K11/AS4 Interlaminar Mode II Shear Fracture Surface Exposed to MEK for 24 Hours

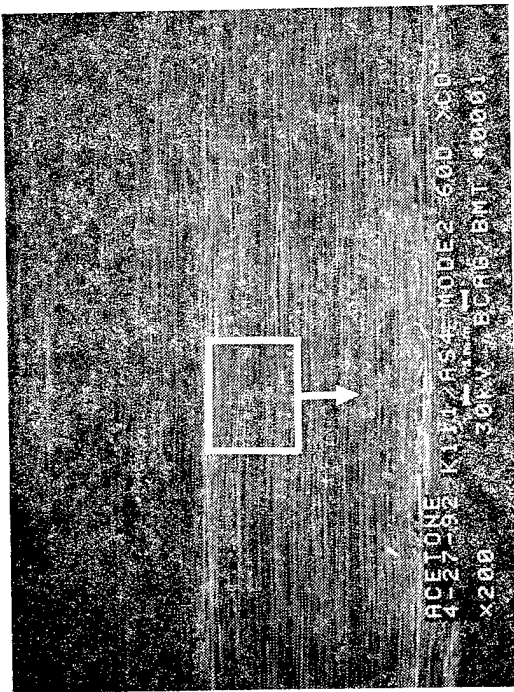
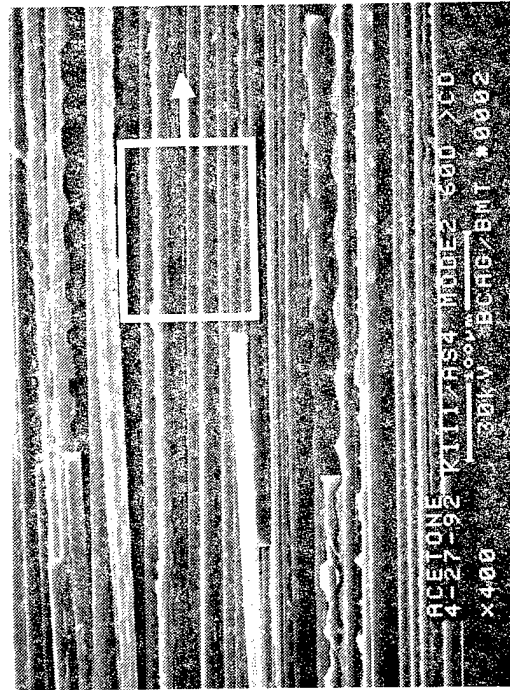
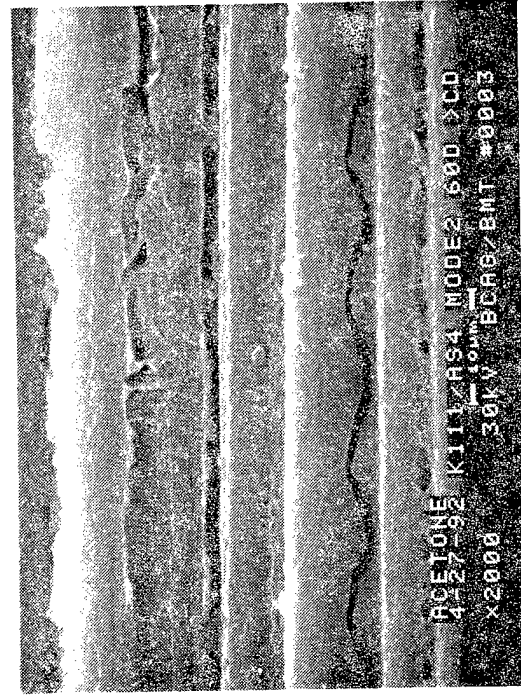
Figure 3.2-23. SEM Fractographs of a K111/AS4 Interlaminar Mode II Shear Fracture Surface Exposed to Acetone for 24 Hours

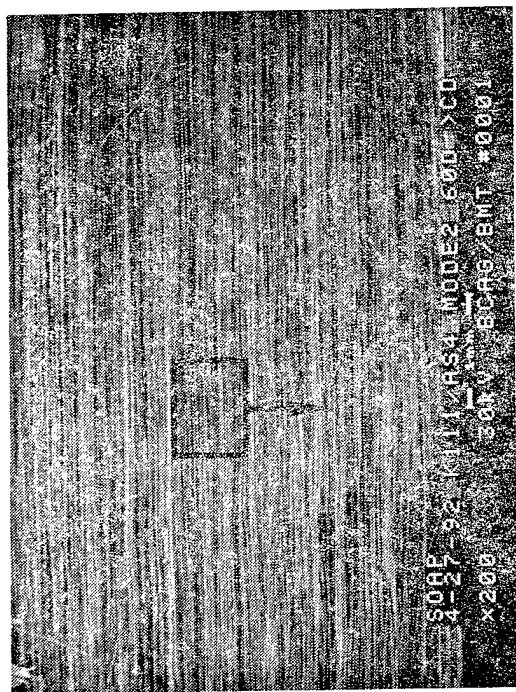
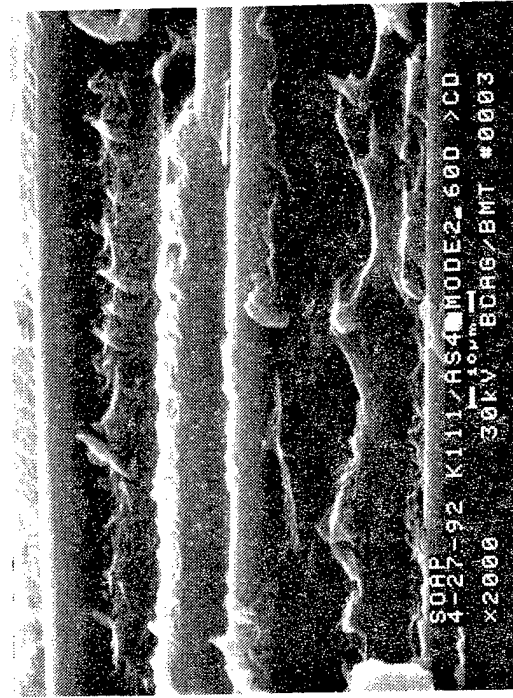
Figure 3.2-24. SEM Fractographs of a K111/AS4 Interlaminar Mode II Shear Fracture Surface Exposed to Soap Solution for 24 Hours

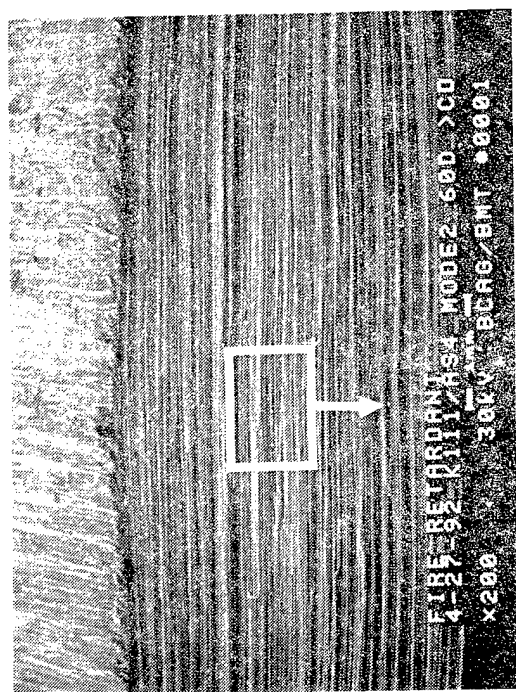
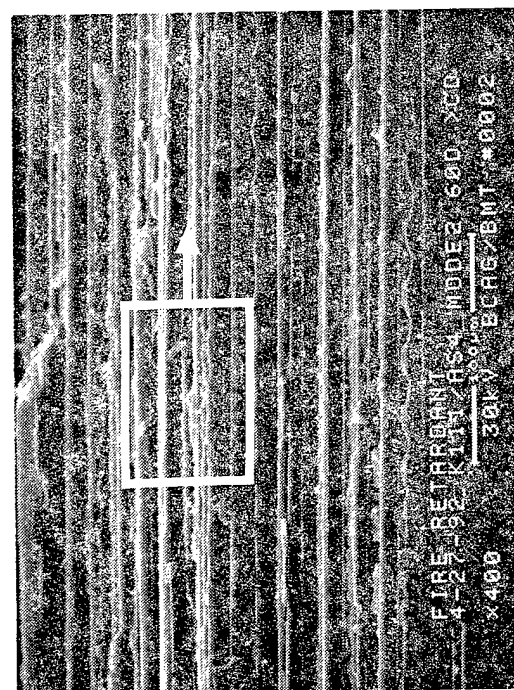
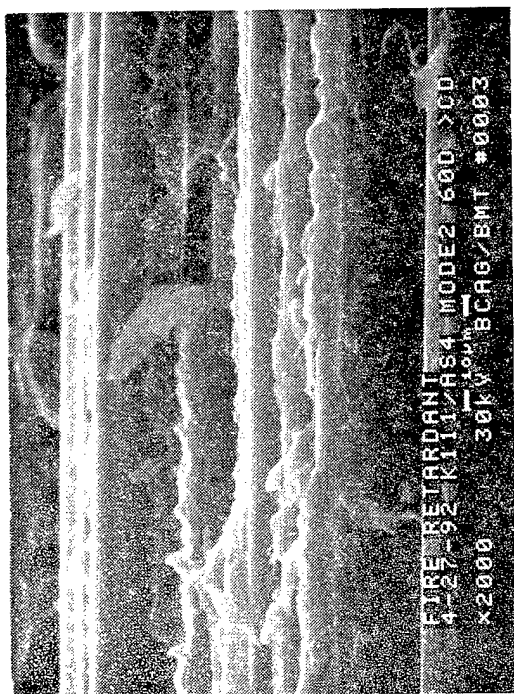
Figure 3.2-25. SEM Fractographs of a K111/AS4 Interlaminar Mode II Shear Fracture Surface Exposed to Fire Retardant Foam for 7 Days

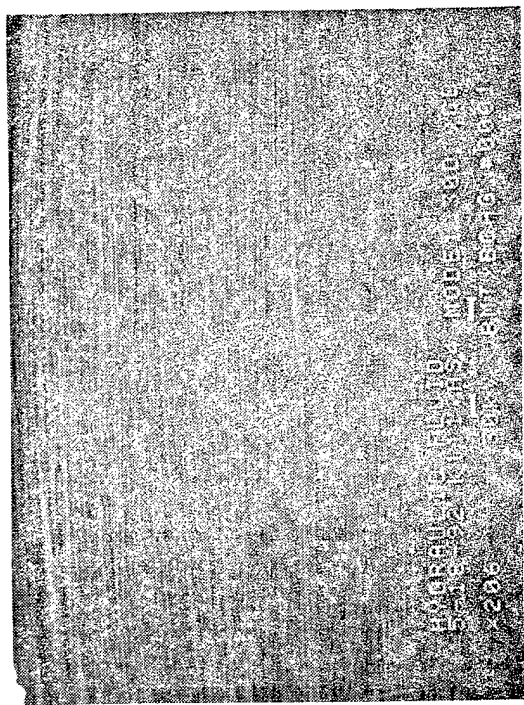
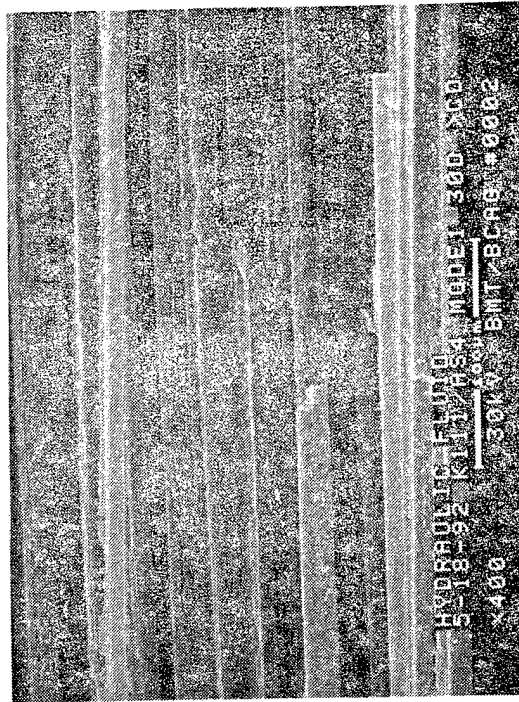
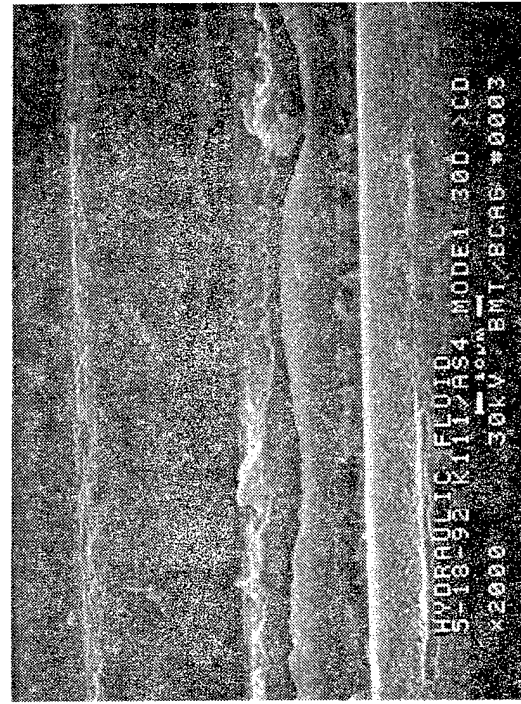
Figure 3.2-26. SEM Fractographs of a Kill/AS4 Interlaminar Mode I Tension Fracture Surface Exposed to Hydraulic Fluid for 7 Days

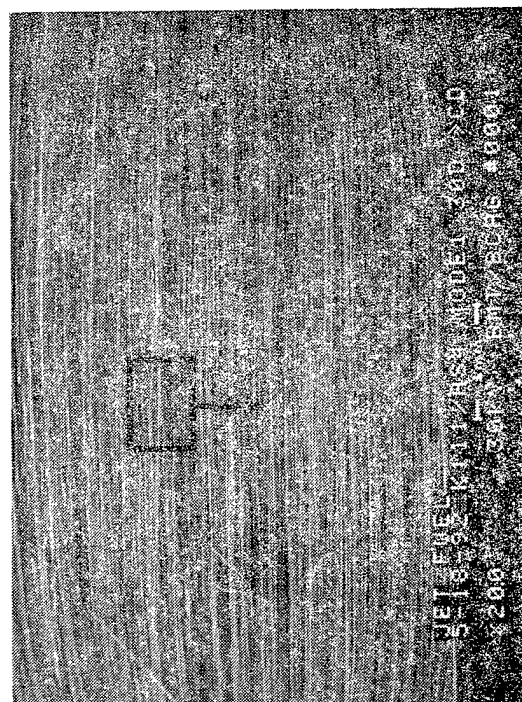
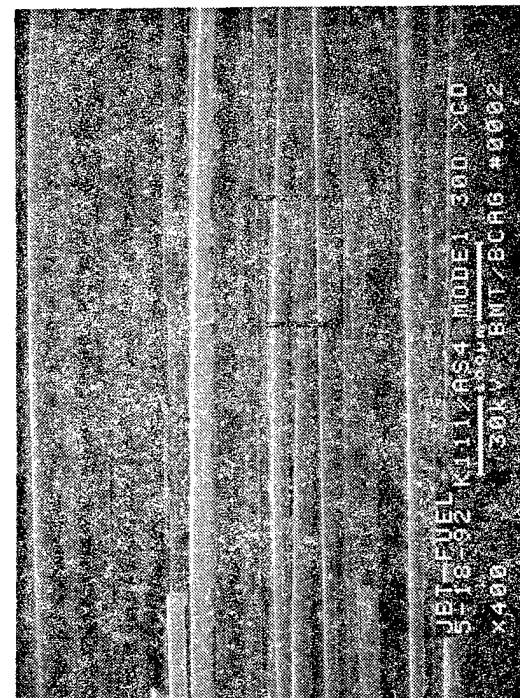
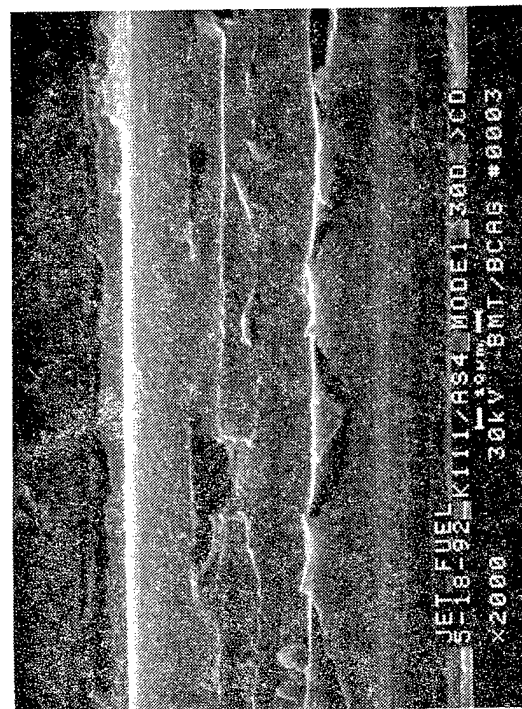
Figure 3.2-27. SEM Fractographs of a K111AS4 Interlaminar Mode I Tension Fracture Surface Exposed to JP4 Jet Fuel for 7 Days

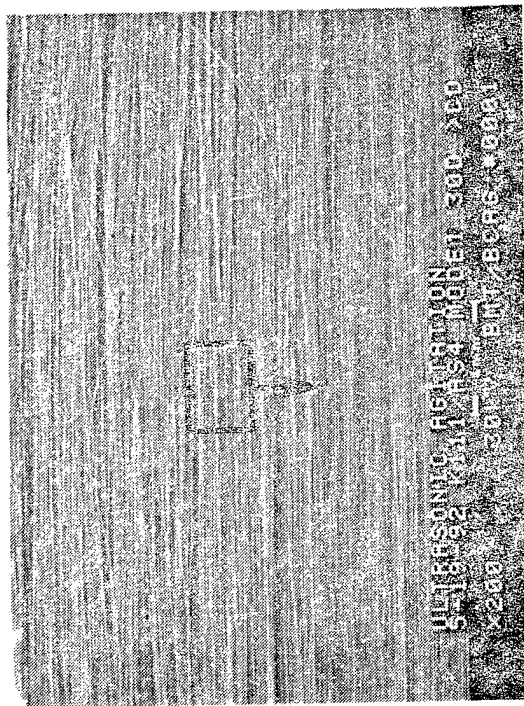
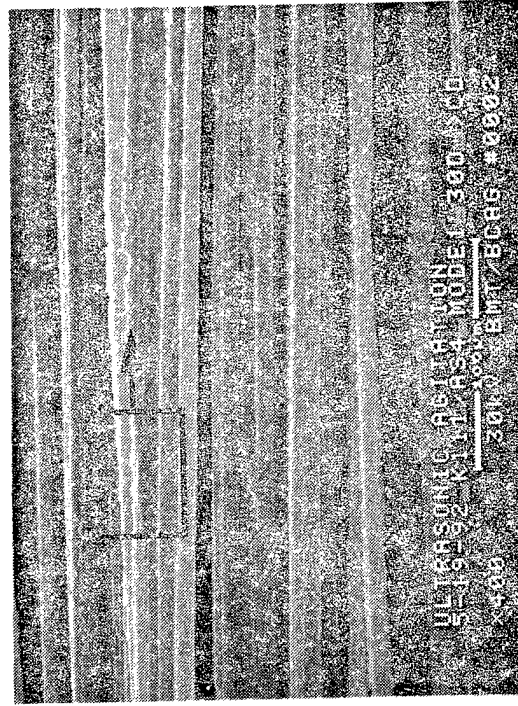
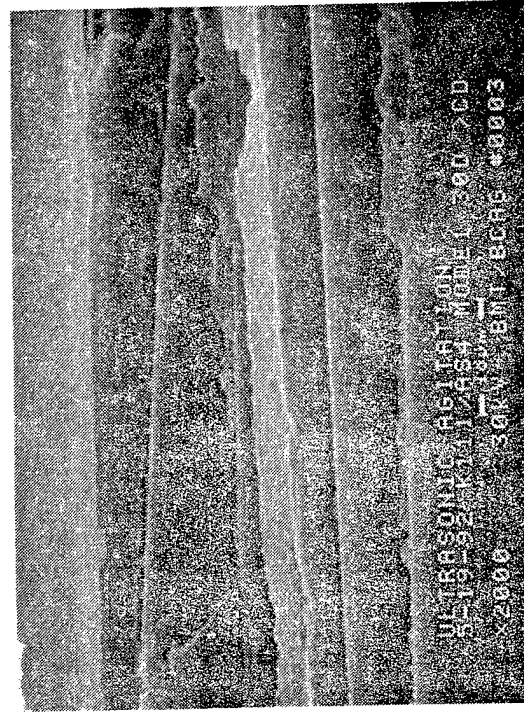
Figure 3.2-28. SEM Fractographs of a K111/AS4 Interlaminar Mode I Tension Fracture Surface Exposed to Ultrasonic Agitation in Distilled Water for 24 hours

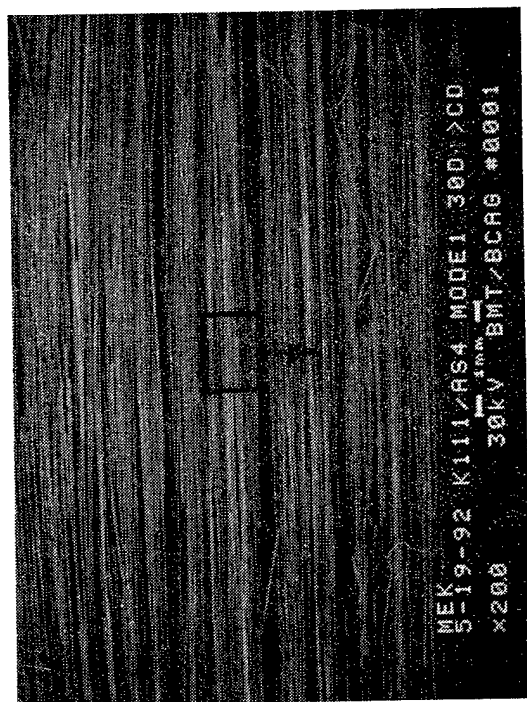
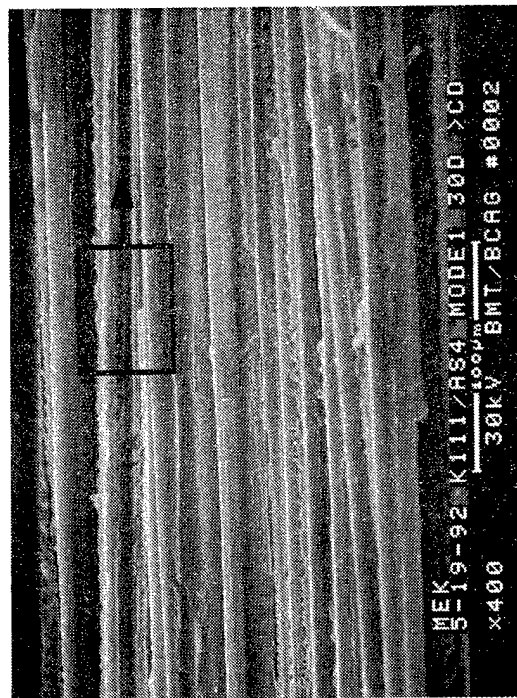
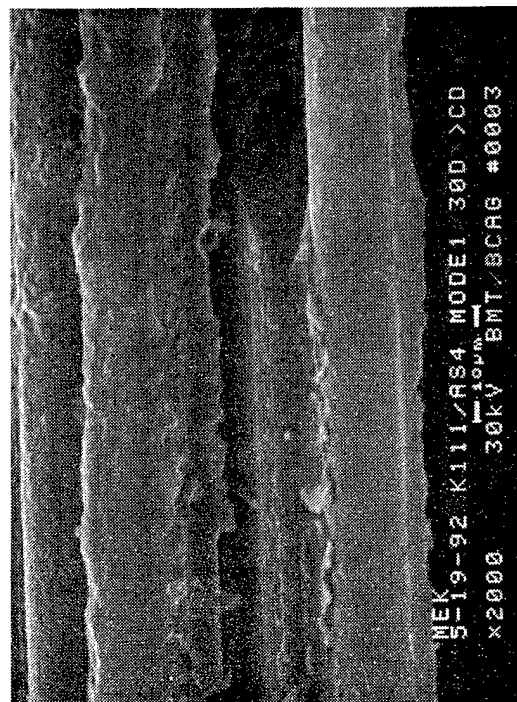
Figure 3.2-29. SEM Fractographs of a K111/AS4 Interlaminar Mode I Tension Fracture Surface Exposed to MEK for 24 Hours

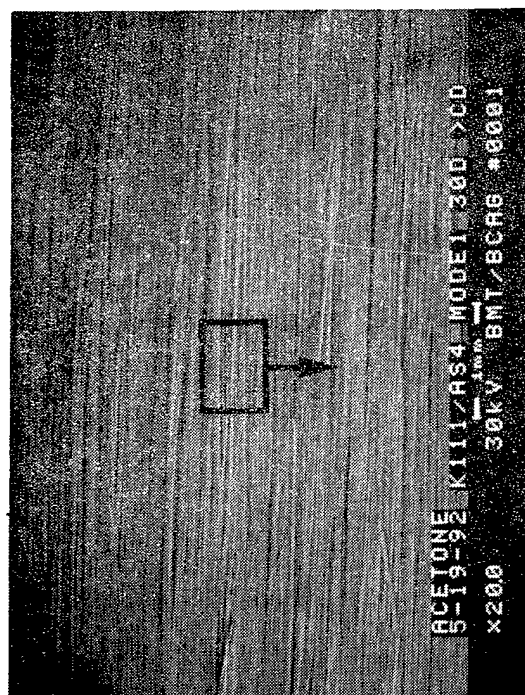
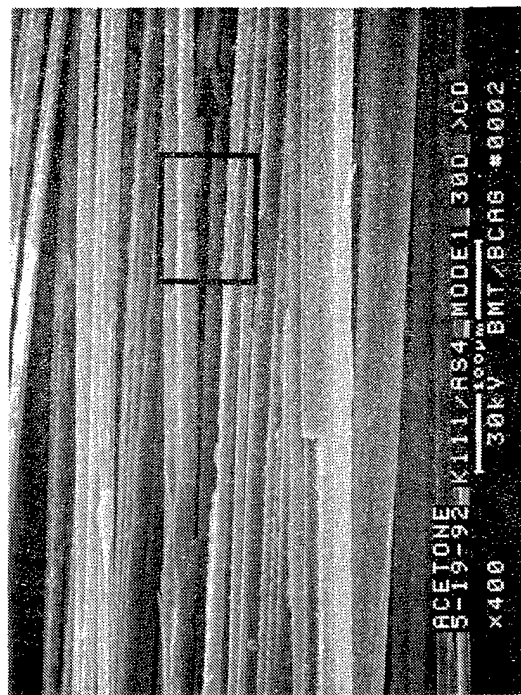
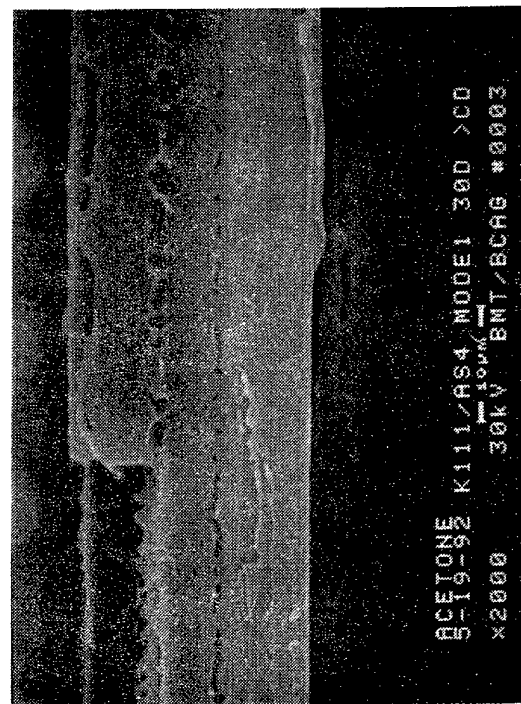
Figure 3.2-30. SEM Fractographs of a K111/AS4 Interlaminar Mode I Tension Fracture Surface Exposed to Acetone for 24 hours

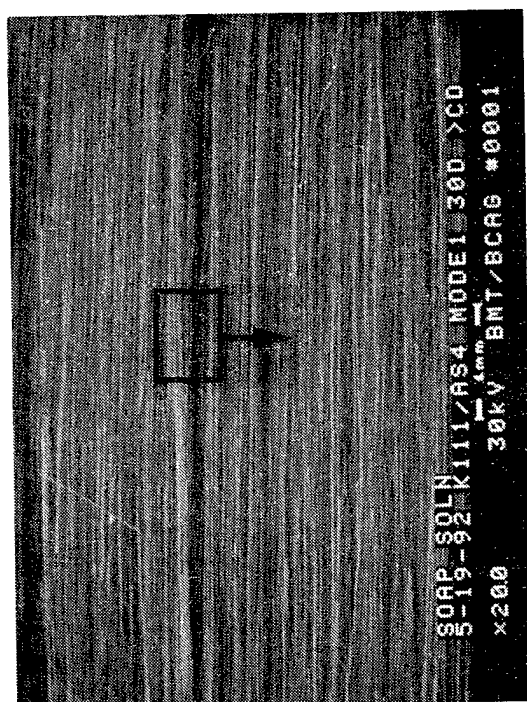
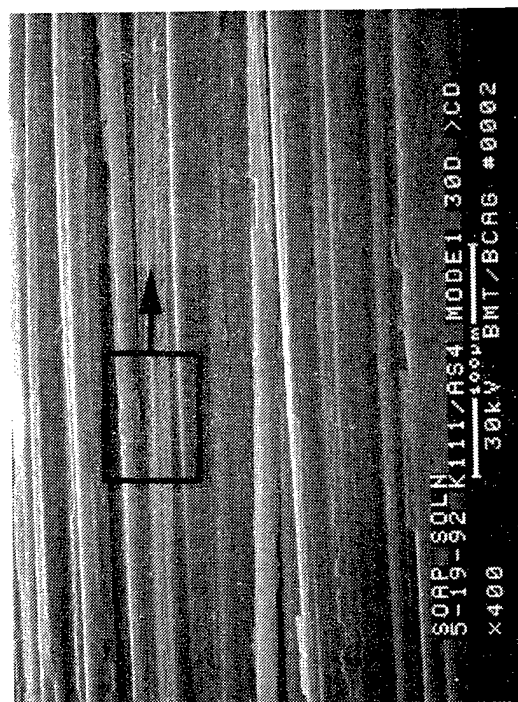
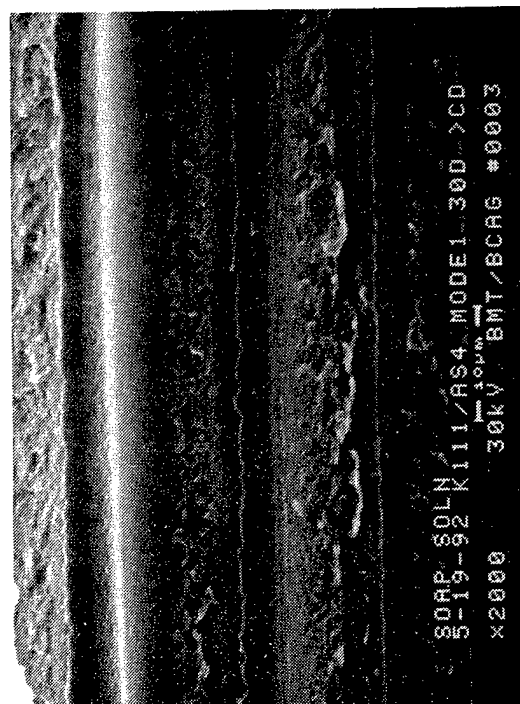
Figure 3.2-31. SEM Fractographs of a K111/AS4 Interlaminar Mode I Tension Fracture Surface Exposed to Soap Solution for 24 hours

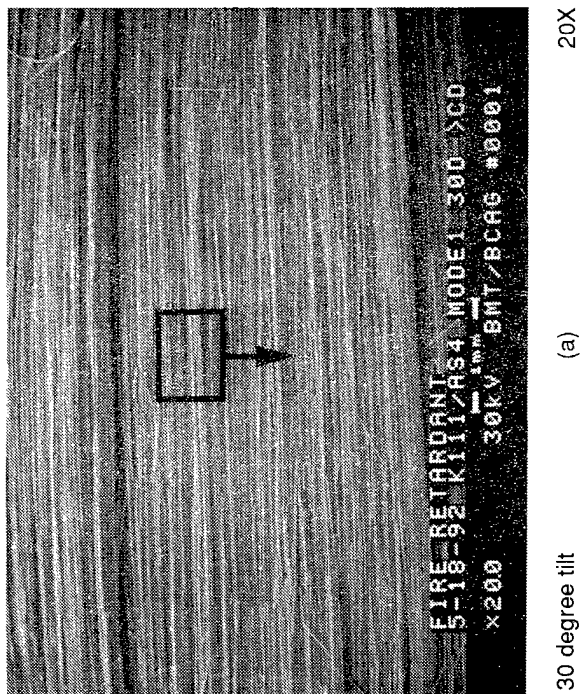
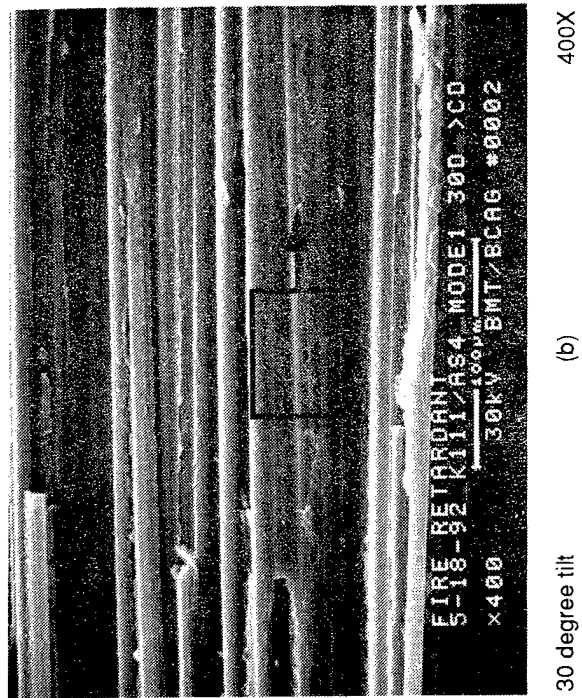
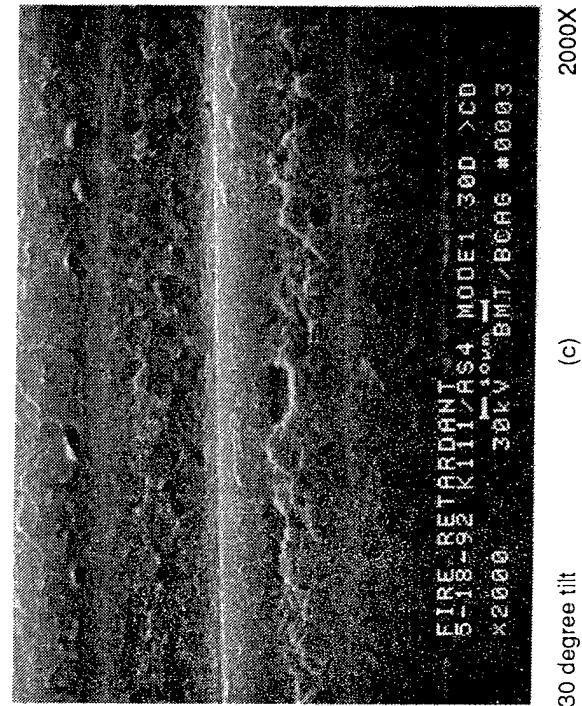
Figure 3.2-32. SEM Fractographs of a KIIII/AS4 Interlaminar Mode I Tension Fracture Surface Exposed to Fire Retardant Foam for 7 Days

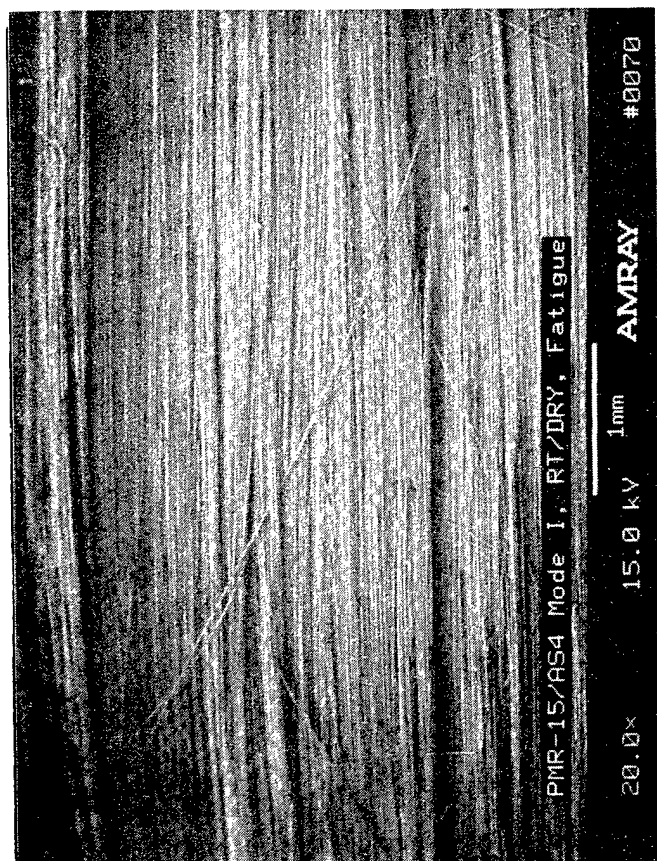
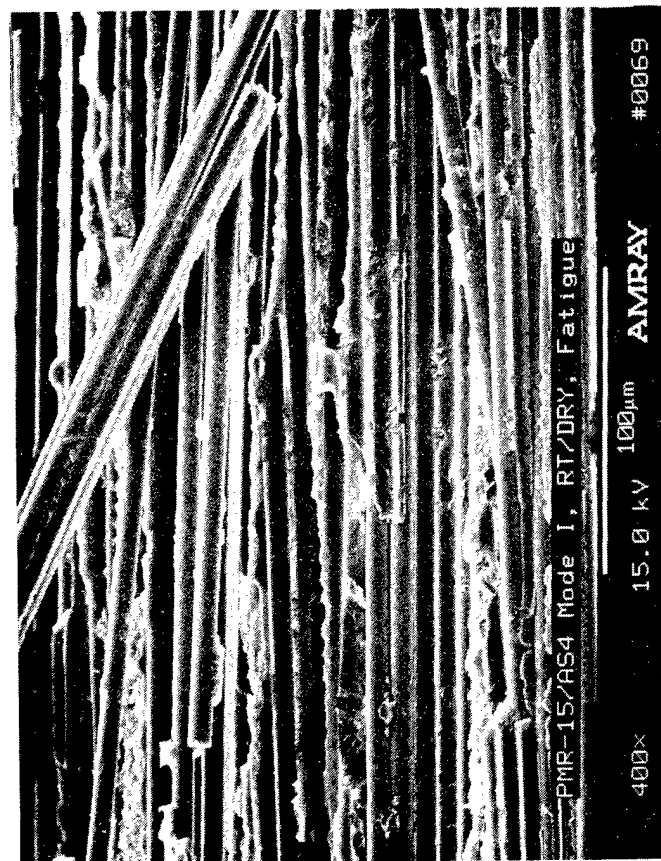
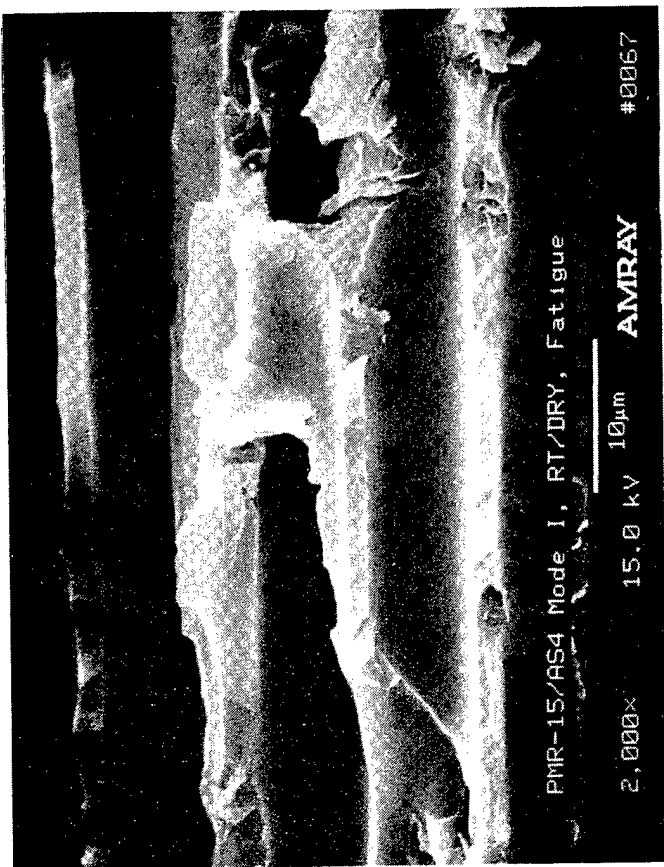
The overall surface morphology exhibited similar features as the fracture surface of a statically loaded specimen (Figure 3.3-1). Rivermarks and hackles were observed including fatigue striations. However, the striation features, which were usually located in fiber pull out troughs, were very difficult to identify even at very high magnifications (Figure 3.3-2a). These striations were also observed in resin rich regions, which resembled typical "beach marks" in fatigued metals (Figure 3.3-2b).

Figure 3.3-1. SEM Fractographs of a PMR-15/AS4 Interlaminar Mode I Tension Fatigue Fracture Surface, RT/Dry

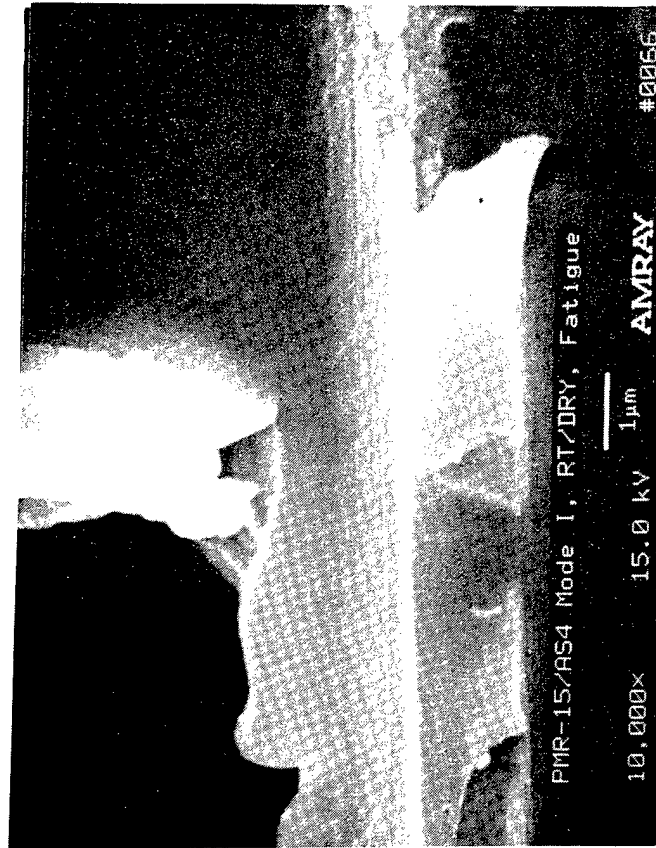
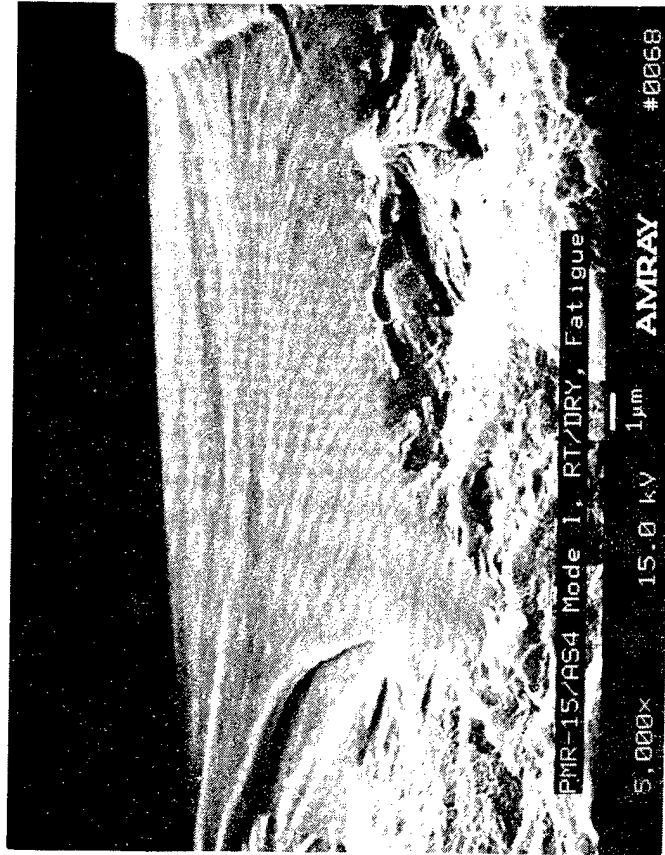
Figure 3.3-2. High-Magnification SEM Fractographs of a PMR-15/AS4 Interlaminar Mode I Tension Fatigue Fracture Surface, RT/Dry

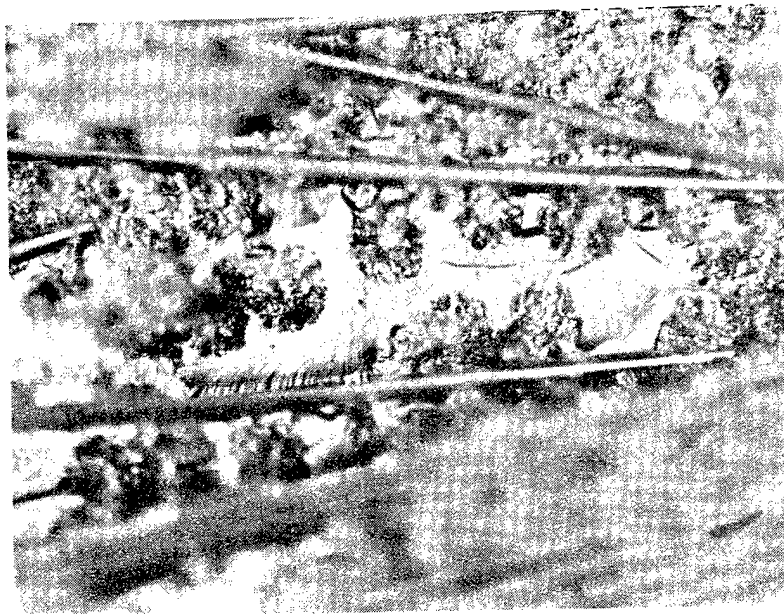
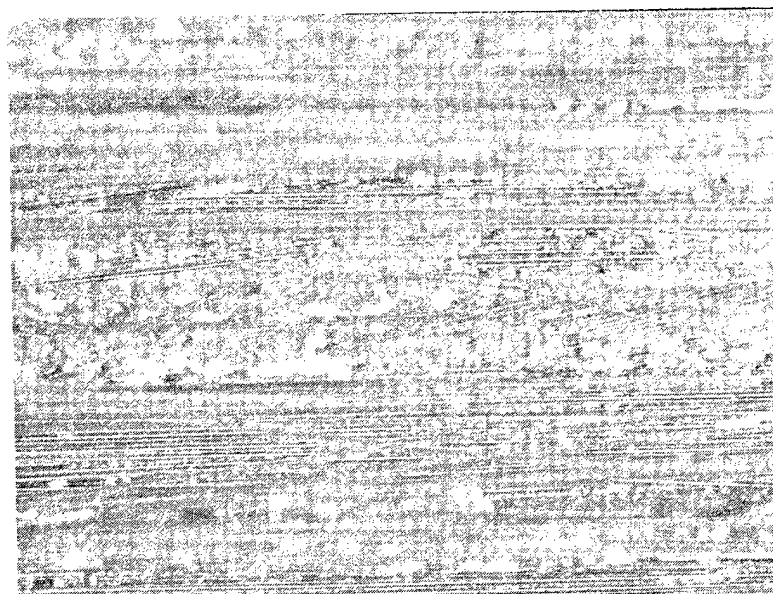
However the 350°F specimen fracture surface did not exhibit the typical mode I (tension) features. The fracture features were not distinct enough to determine the overall crack propagation direction

Figure 3.3-3. Optical Fractographs of a PMR-15/AS4 Interlaminar Mode I (Tensile) Fatigue Fracture Surface, 350° F

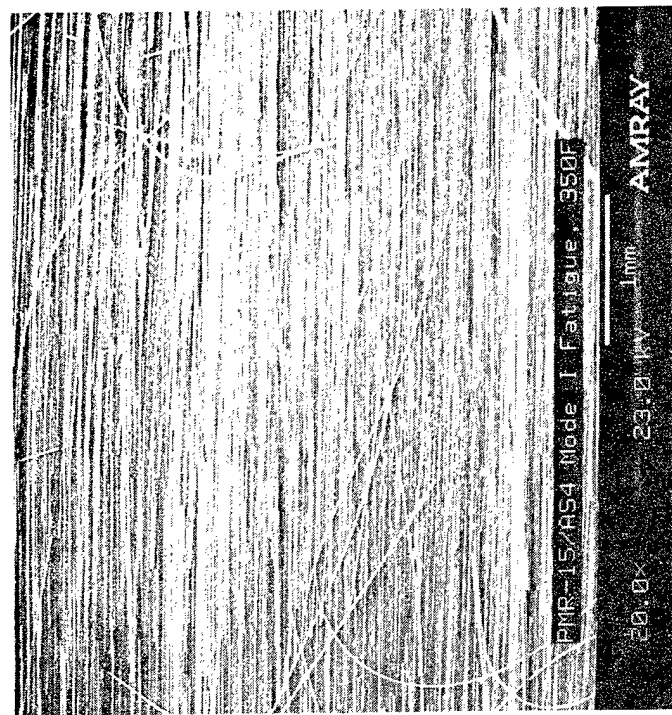
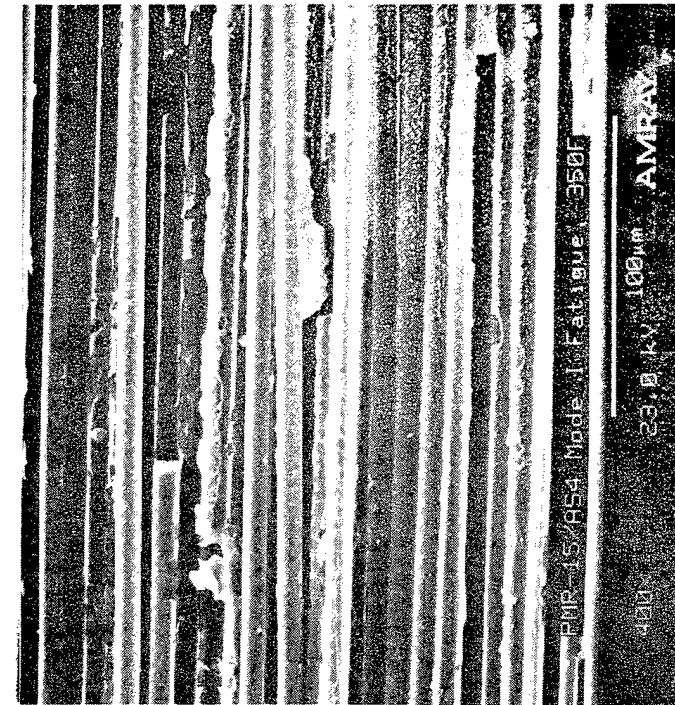
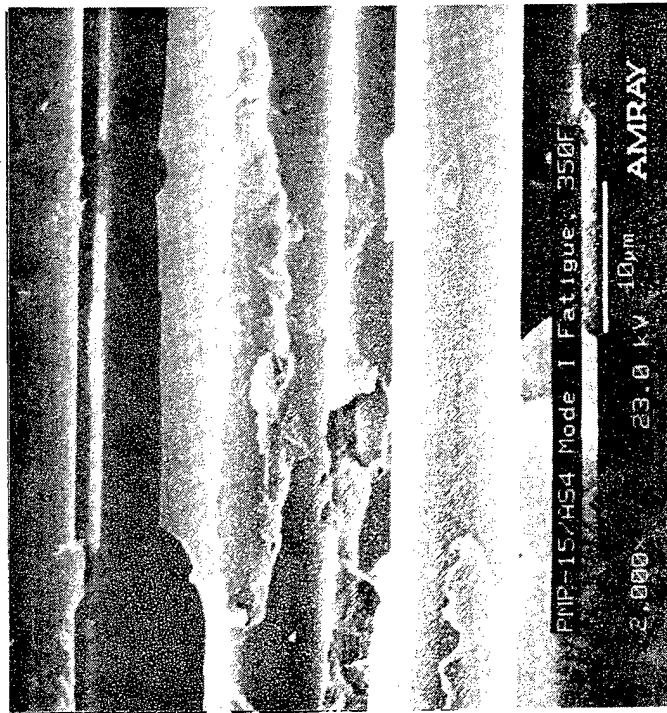
Figure 3.3-4. SEM Fractographs of a PMR-15/AS4 Interlaminar Mode I (Tensile) Fatigue Fracture Surface, 350° F

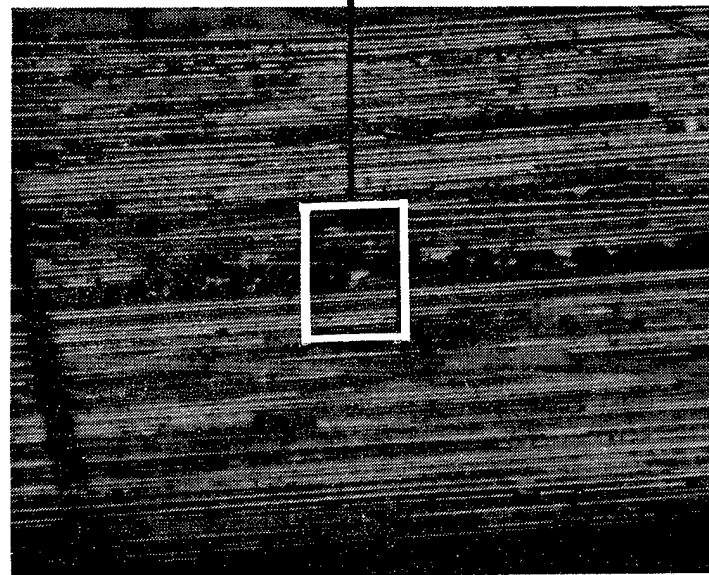
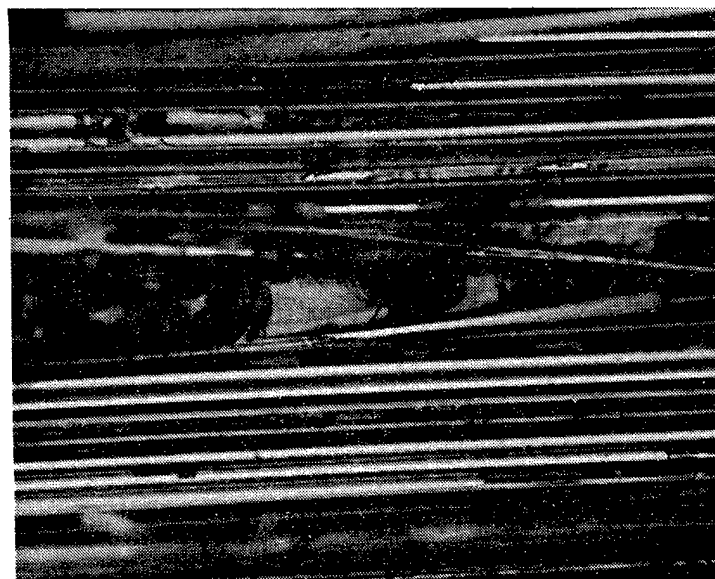
Figure 3.3-5. Optical Fractographs of PMR-15/AS4 Interlaminar Mode II (Shear) Fatigue, Room Temperature, High Stress

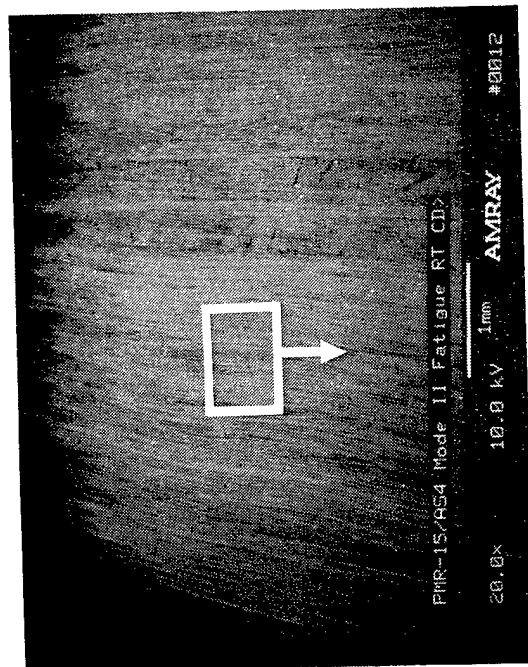
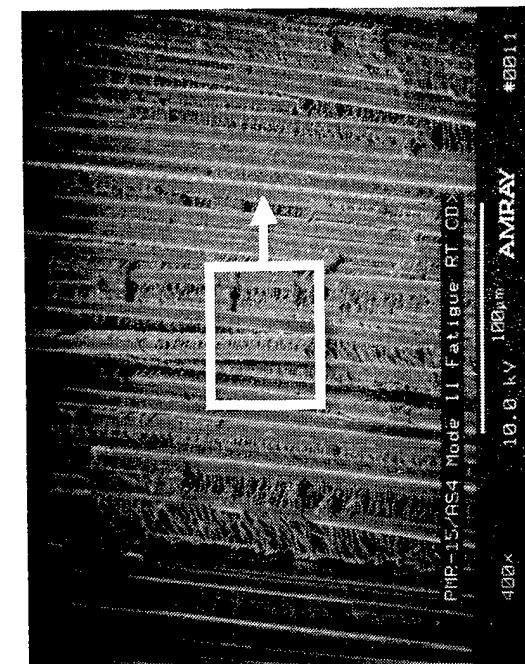
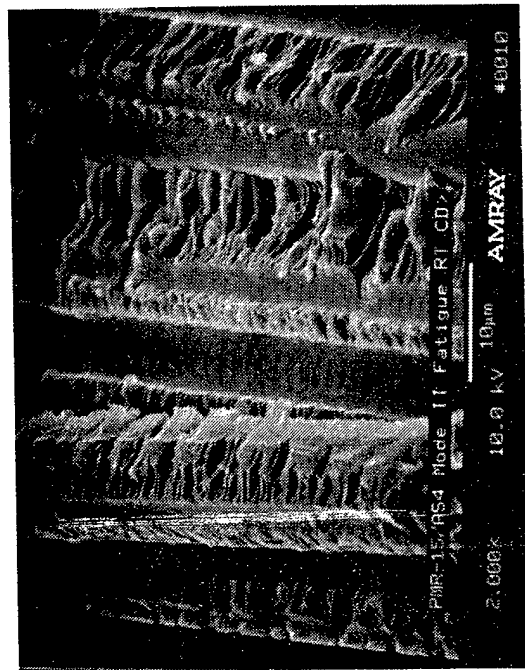
Figure 3.3-6. SEM Fractographs of a PMR-15/AS4 Interlaminar Mode II (Shear) Fatigue Fracture Surface, Room Temperature

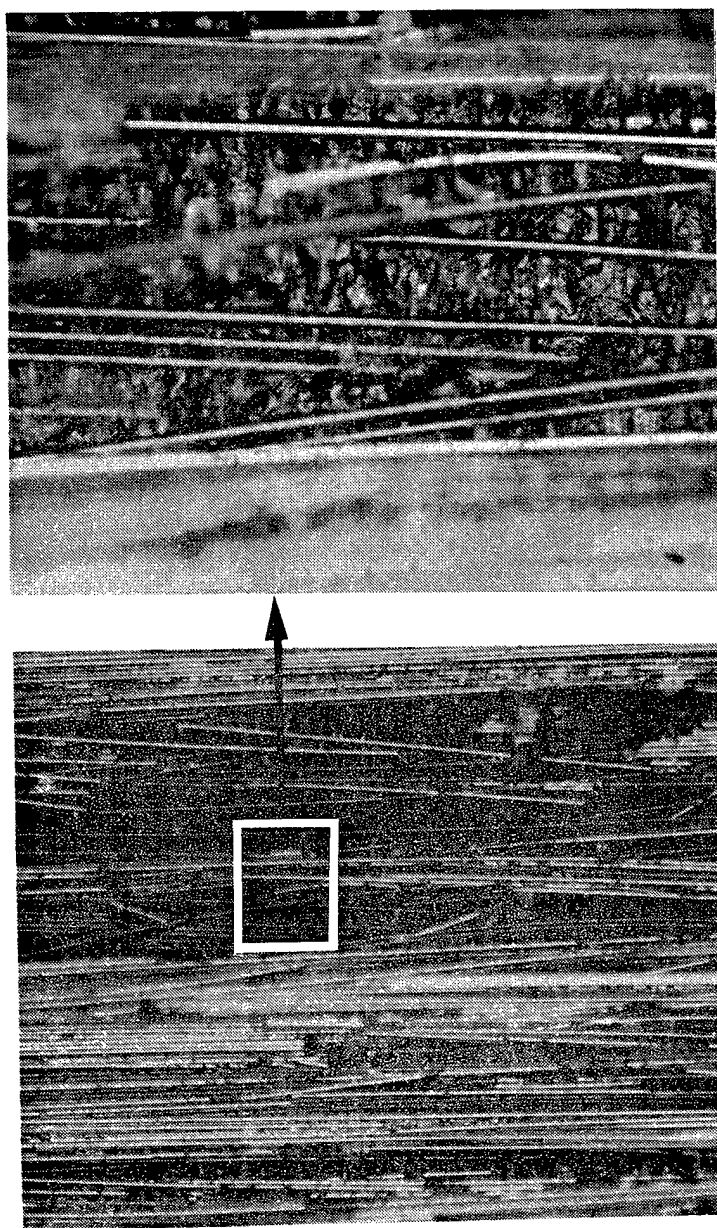
Figure 3.3-7. Optical Fractographs of PMR-15/AS4 Interlaminar Mode II (Shear) Fatigue, 350° F, High Stress

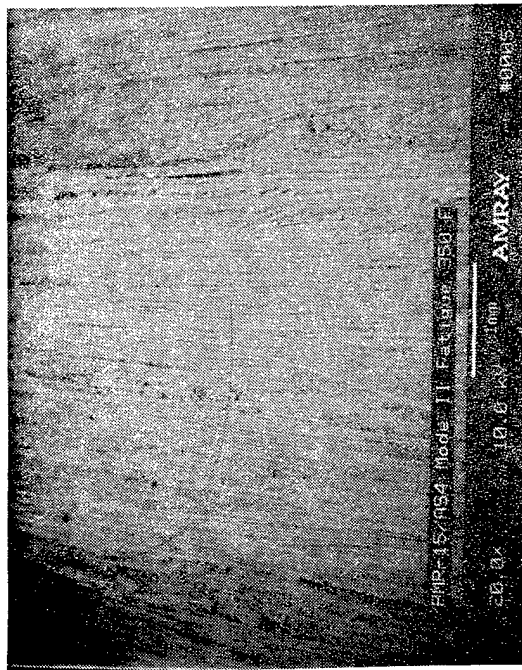
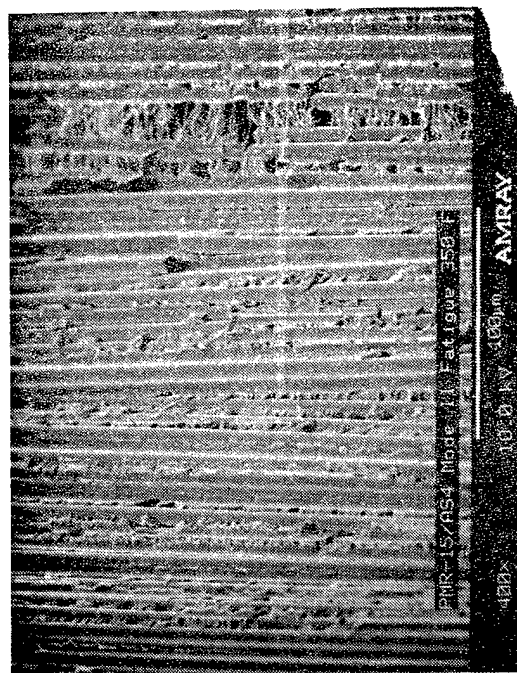
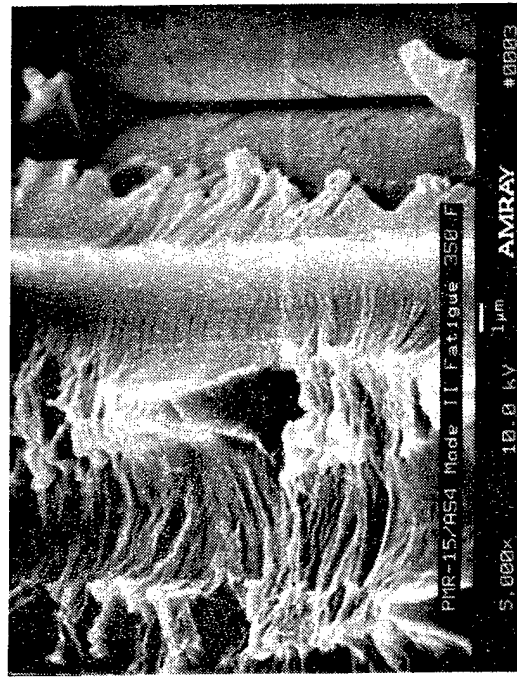
Figure 3.3-8. SEM Fractographs of a PMR-15/AS4 Interlaminar Mode II (Shear) Fatigue Fracture Surface, 350°F

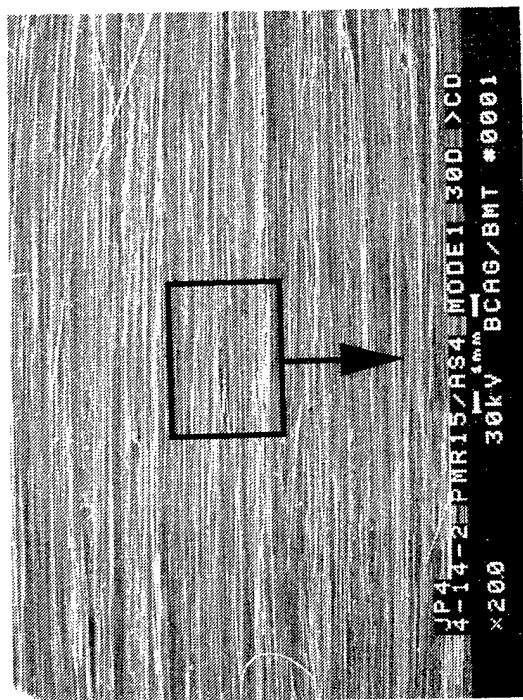
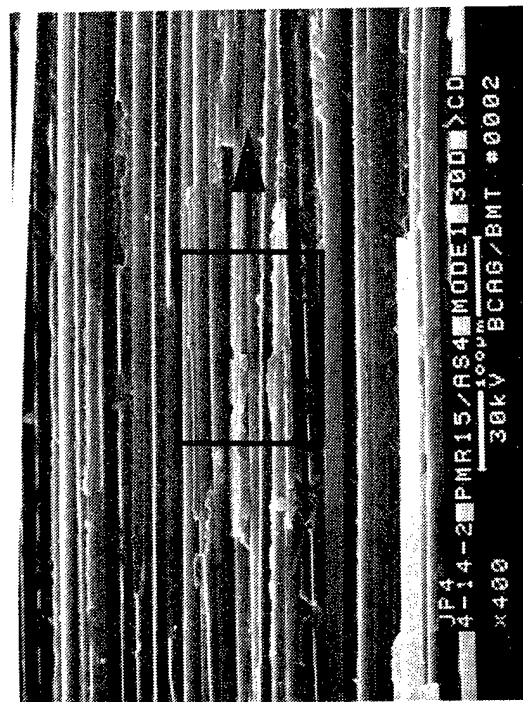
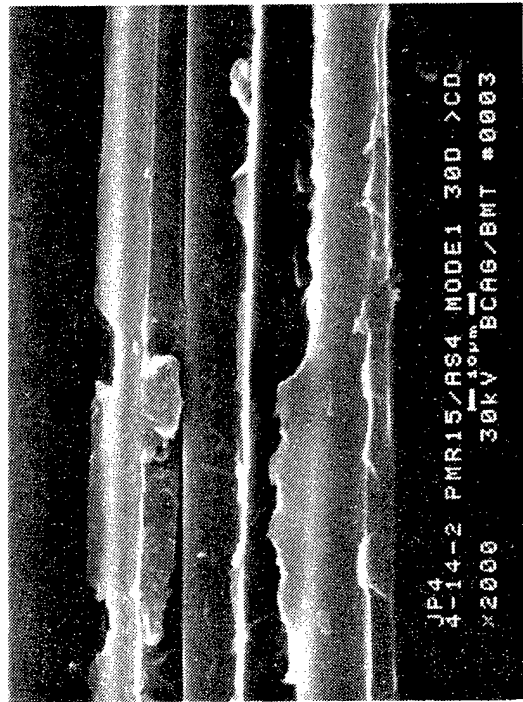
The effects of the exposure did not affect the fracture morphology to any noticeable degree. All of the characteristic mode I surface features were easily identified (Figure 3.3-9 through 3.3-15).

Figure 3.3-9. SEM Fractographs of a PMR-15/AS4 Interlaminar Mode I Tension Fracture Surface Exposed to JP4 Jet Fuel for 7 Days
